Phytoremediation Pilot Study Summary Report

Wetland Area

Dayco Corporation/L.E. Carpenter Superfund Site, Wharton, New Jersey

February 2017

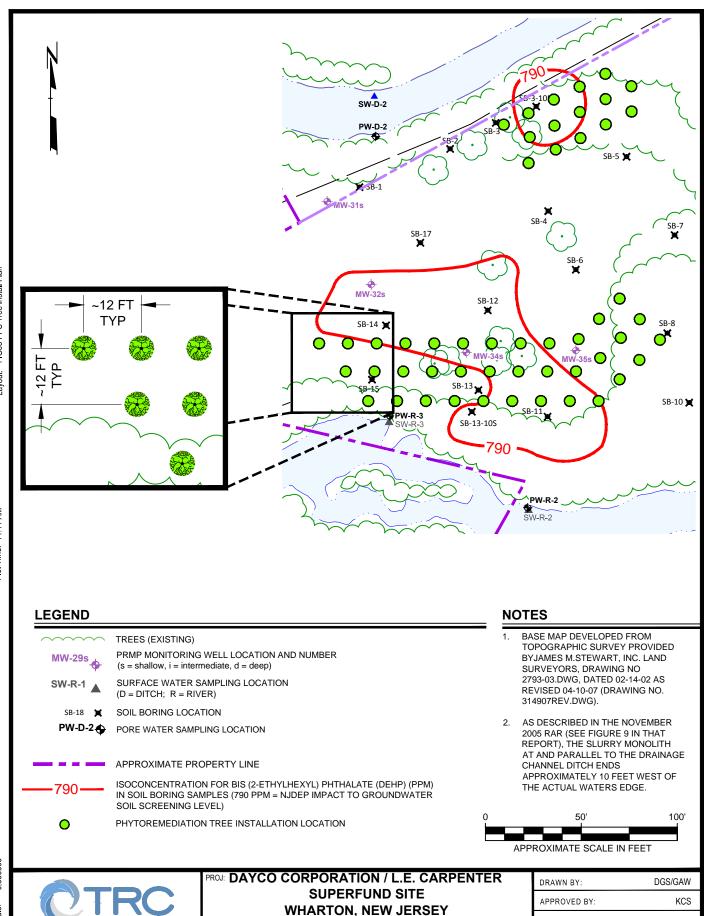
TITLE: PHYTOREMEDIATION PILOT STUDY TREE INSTALLATION DETAIL

Figure 2-4. Tree locations were adjusted to accommodate existing established trees, and other obstructions. The boreholes were lined to a depth of approximately 8 feet below grade, to intersect the interval of highest observed COC concentrations. The casing material was galvanized iron, plastic piping, or plastic casing. An aeration tube was installed to the bottom of the hole and extended to 2 feet above the hole. The hole was backfilled with topsoil to 2 or 3 feet below ground surface (fbgs). A slow release commercial fertilizer was added at a rate of ½ lb. of 13-13-13 (N-P-K) fertilizer per location. Water was added to the backfilled soil to settle the soil and remove air pockets. The tree was then placed in the center of the borehole and the roots covered with additional topsoil. The loose friable backfill was worked around the roots and thoroughly settled with water to insure good root/soil contact. Care was taken to avoid bruising or breaking the roots. Soil was slightly mounded around the tree to minimize surface water flow into the tree borehole and to avoid surface water ponding. Coarse material backfill was then added to bring the borehole to approximately 1 foot above grade.

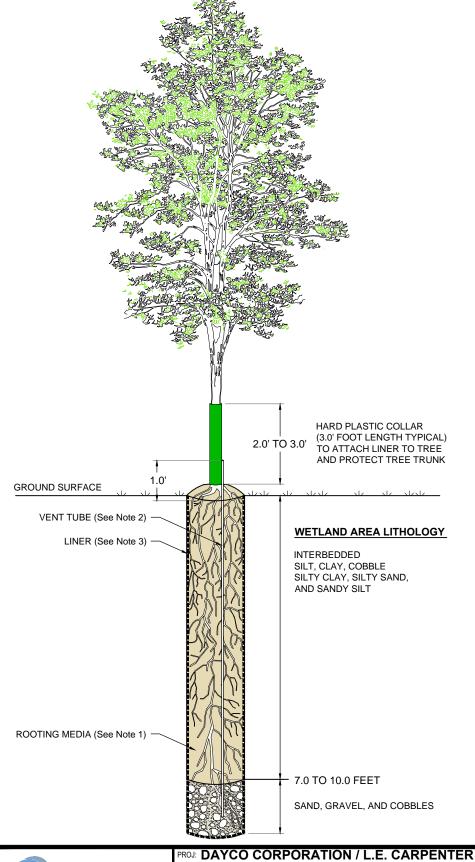
FILE NO.
 269799.0.0 Figure 2-3.dwg

growth in deeper zones and root zone hydration through groundwater rather than infiltrating rainwater, a root management system called TreeWell® was used for installation of the pilot study. The TreeWell® system is effective in constraining propagation of shallow root systems and encouraging tree root growth downward to the water table. A schematic cross section of a TreeWell® System is presented in Figure 2-3.

- ROOTING MEDIA IS A
 COMBINATION OF SITE SOILS
 AND TOPSOIL/POTTING SOIL
 WITH AMENDMENTS.
- 2. VENT TUBE IS A 2-INCH DIAMETER CORRUGATED SLOTTED DRAINAGE PIPE.
- LINER IS 6 MIL PVC OR ALTERNATIVE MATERIAL DEPENDING ON SITE CONDITIONS.

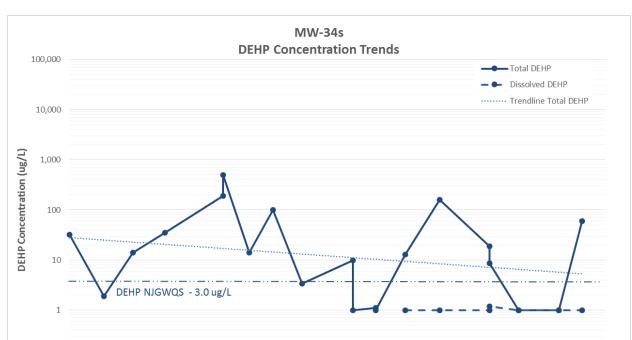
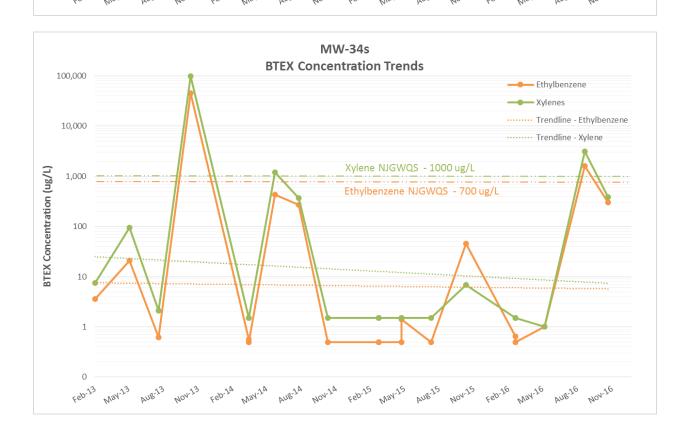
Figure 3-3a Time vs COC Concentrations in Wetland Area Monitoring Well MW-34s

When compared to pre-pilot baseline trends, the time versus concentration graphs for MW-34s indicate an improved declining trend for total DEHP and observed BTEX compounds (ethylbenzene and xylene). For DEHP in MW-34s, dissolved DEHP has not been detected since installation of the pilot study and over 50 percent (ten of 18) of the quarterly samplings have displayed either non-detectable total DEHP or total DEHP concentrations below the New Jersey Ground Water Quality Standard (NJGWQS). The total DEHP trendline is approaching the NJGWQS. Ethylbenzene and xylene are generally observed below their respective NJGWQS in MW-34s, only three xylene and two ethylbenzene concentrations have been detected above their respective NJGWQS in the 18 quarterly sampling events following pilot study installation. The ethylbenzene and xylene trendlines are below their respective NJGWQS.

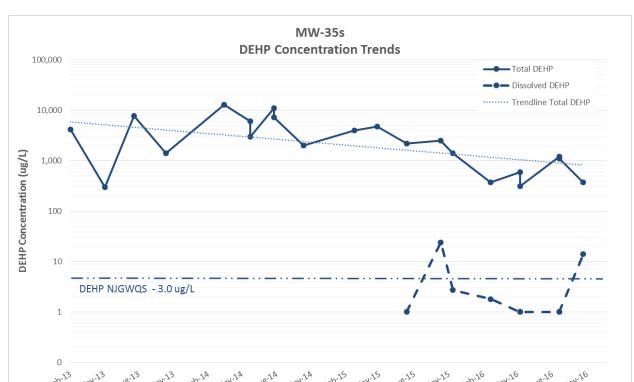
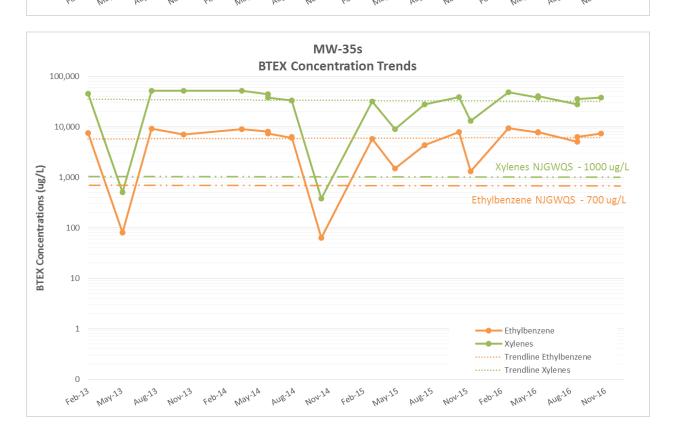
Figure 3-3b Time vs COC Concentrations in Wetland Area Monitoring Well MW-35s

When compared to pre-pilot baseline trends, the time versus concentration graphs for MW-35s indicate an improved declining trend for total DEHP. However, the trends for observed BTEX compounds (ethylbenzene and xylene) are not materially changed from pre-pilot trends. For DEHP in MW-35s, dissolved DEHP is not detected or below the NJGWQS in five of seven samples. Total DEHP concentrations remain above the NJGWQS, but have declined over an order of magnitude since installation of the phytoremediation pilot. Ethylbenzene and xylene are generally observed above the NJGWQS in MW-35s, however three of 18 quarterly sampling events did result in ethylbenzene and xylene observations below the NJGWQS.

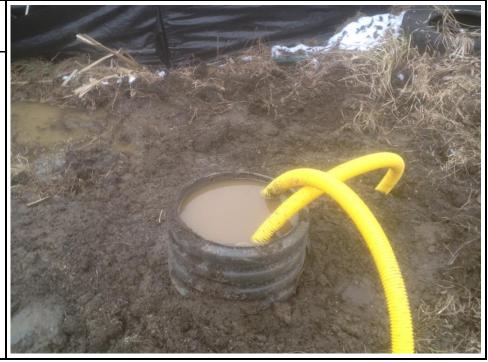
Installation of Tree Well® sleeve and aeration tubes

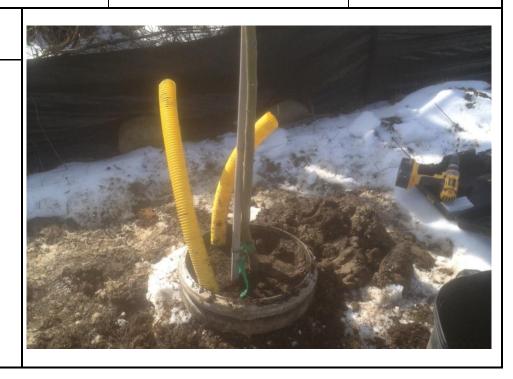
Photo No. Date 5 3/20/2013

DescriptionInstalled Weeping willow

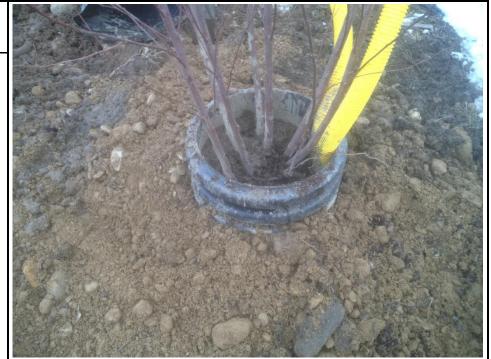
Photo No. Date
6 3/20/2013

DescriptionInstalled River birch

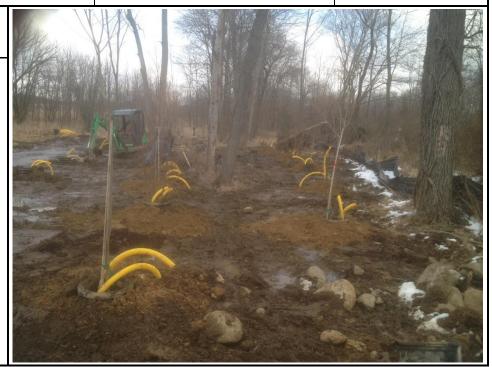
Phytoremediation pilot study area adjacent to the Rockaway River looking east. Multiple planting completed. Notice cobble at surface.

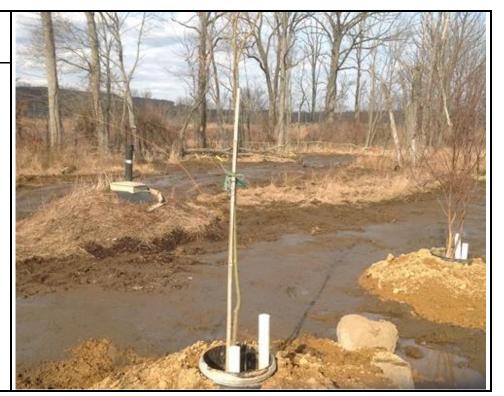
Photo No. Date 8 3/20/2013

Phytoremediation pilot study area adjacent to the Rockaway River looking north at MW-32s. Multiple planting completed.

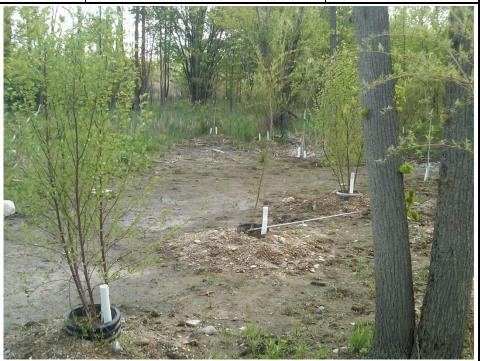
Phytoremediation pilot study area along Rockaway River looking east/southeast. Approximately 2 months post installation.

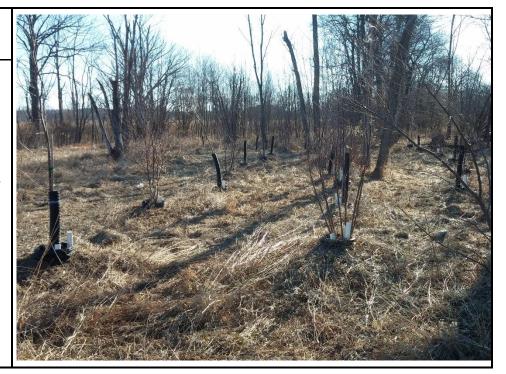
Photo No. Date
10 3/24/2014

Phytoremediation pilot study area along Rockaway River looking east/northeast. Approximately 1 year post installation. Predation sleeves installed to protect young trees.

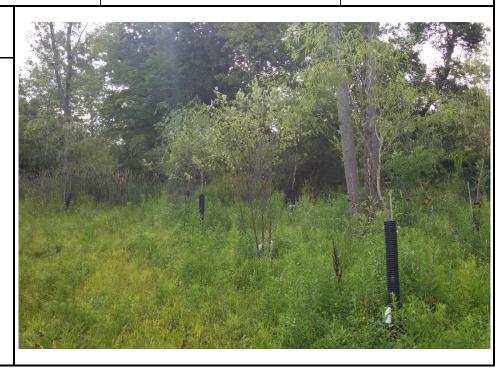
Phytoremediation pilot study area along Rockaway River looking south/southeast. Approximately 18 months post installation.

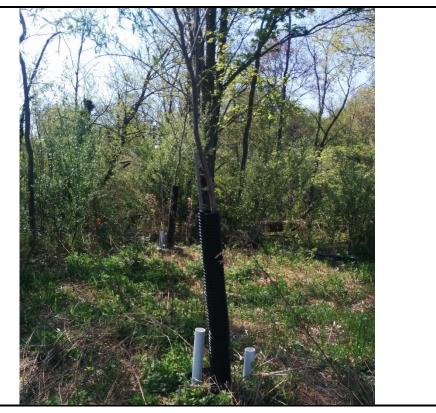
Photo No. Date 5/8/2015 12

Weeping willow approximately 2 years post installation

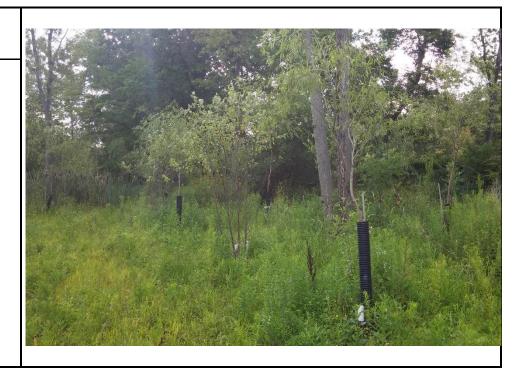
Phytoremediation pilot study area along Rockaway River looking south/southeast.
Approximately 3.5 years post installation.
